DEPARTMENT OF TRANSPORTATION
FEDERAL RAILROAD ADMINISTRATION

ALLEGED FALSE PROCEED SIGNAL REPORT DATE
June 17, 1996

Burlington Northern Santa Fe Railroad
Powder River Division
Valley Subdivision

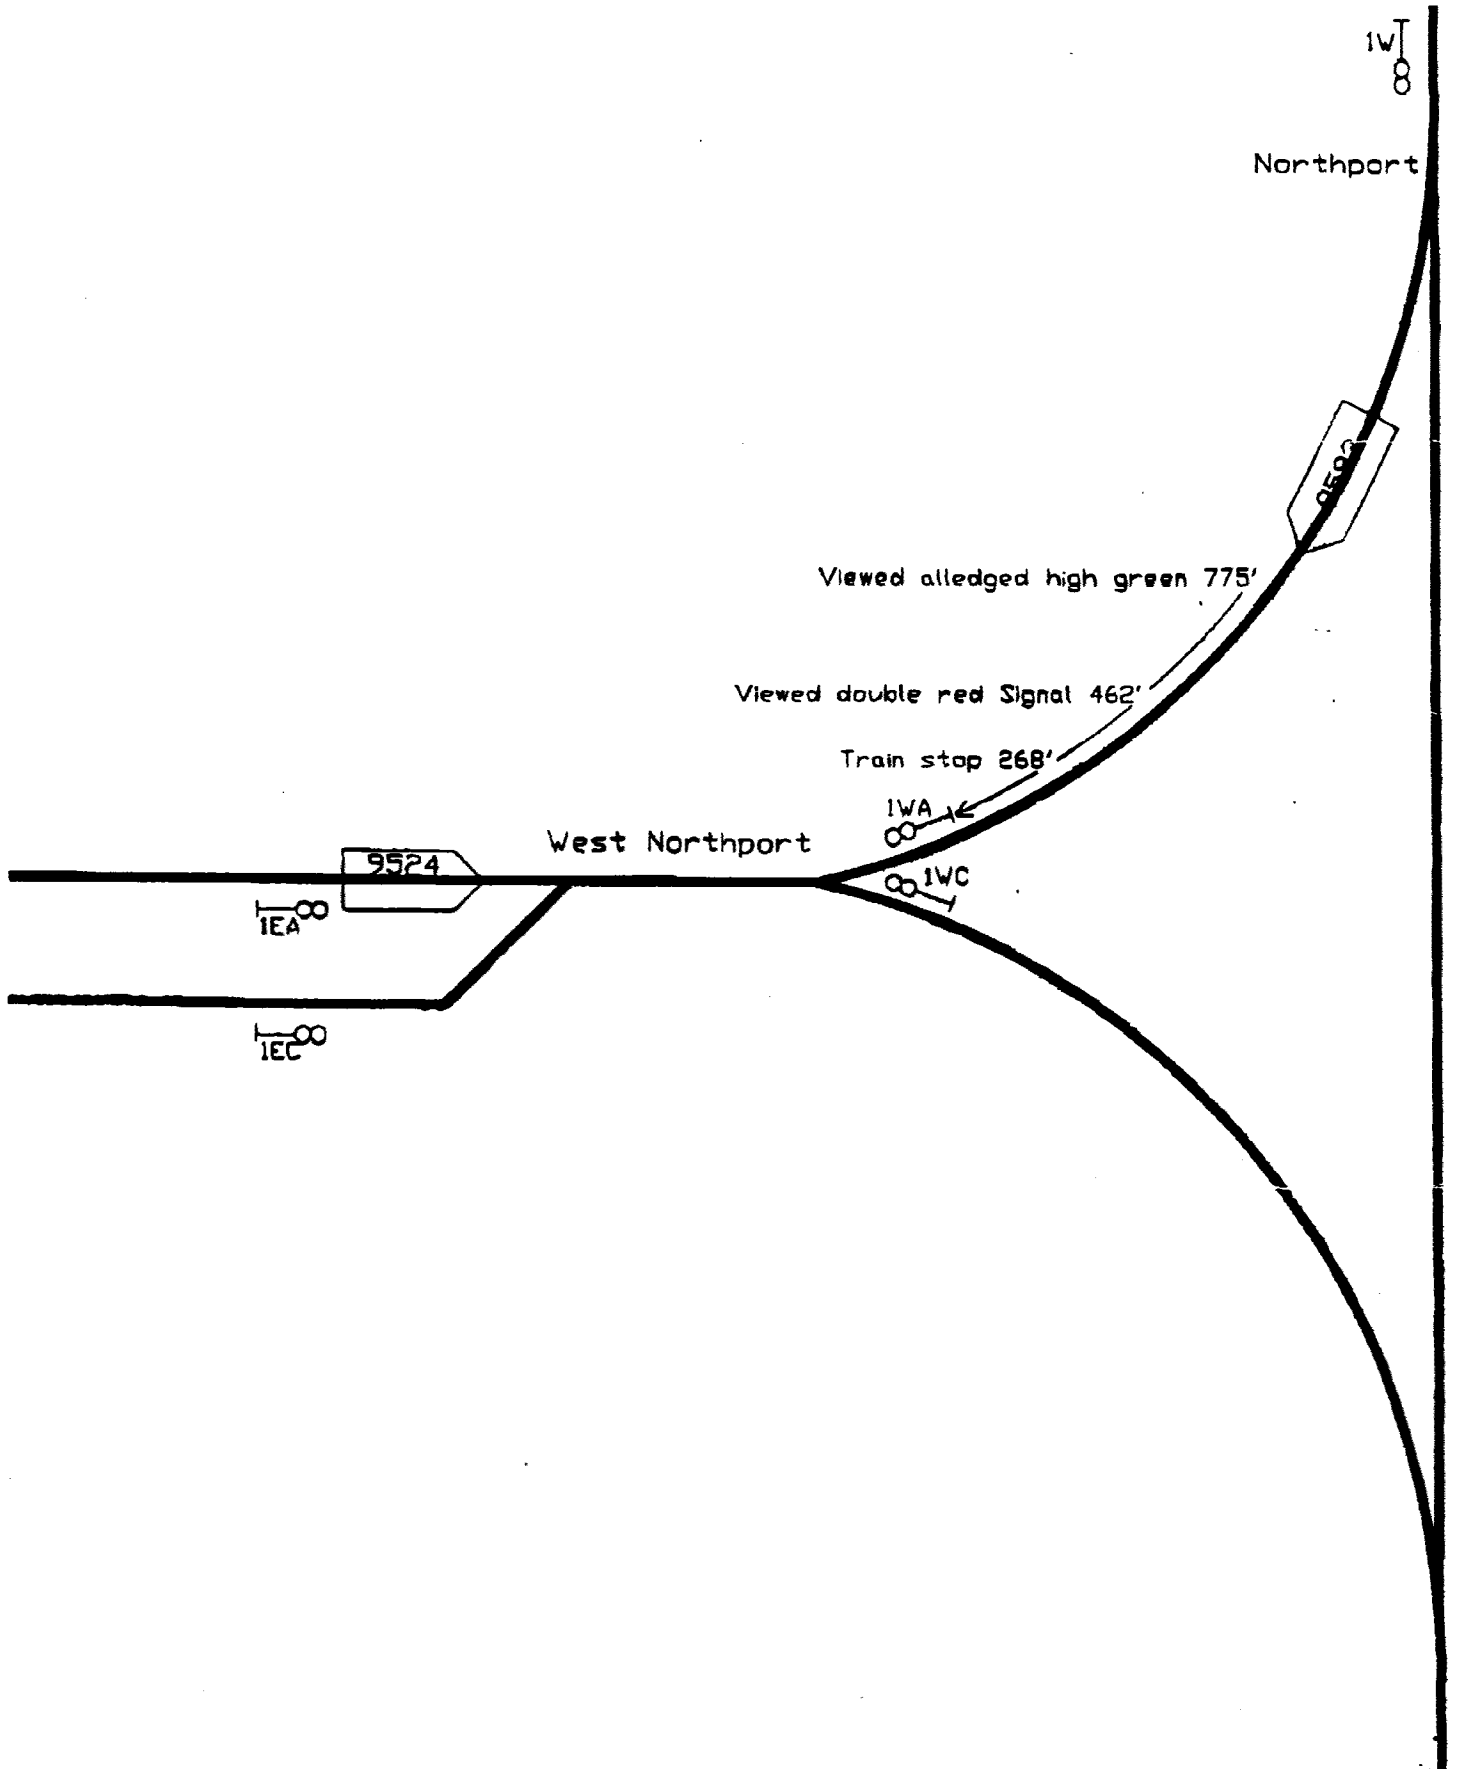
At 12:58 MDT on June 10, 1996, Engineer operating the 9593 West (Train 131RC211) reported a red over yellow aspect at Northport and while approaching West Northport a "high green" was observed at West Northport, while the 9524 East was lined through the West Northport location. Interview with crew of the 9593 revealed that as they approached West Northport, 775 feet from the 1 WA signal, it appeared green. At 462 feet from the 1 WA signal it was observed red over red, and they stopped their train 268 feet from the 1 WA signal. CTC data log and local data in memory at field site indicate 1 WA signal was not requested at West Northport. All signal equipment at West Northport tested. Interlocking tests performed with no exceptions. On June 11, 1996 at 12:58 MDT the area was observed in the same sun light conditions. From the point where the crew alleged a high green, our observation revealed a light colored area on the background of the 1 WA signal. This was caused by bird excrement. The area in question was painted with flat black paint, lenses cleaned, and lamp voltages set at 9.2 Volts to improve visibility of signal. It is our opinion, this is not a false proceed incident. This report is being filed as information only. See diagram attached.
